Region 9 Enforcement Division
75 Hawthorne Street
San Francisco, CA 94105

Inspection Date(s):	9/28/15		
Time:	Entry: 9:30	Exit: 11:45	
Media:	Water		
Regulatory Program(s)	Clean Water Act NPDES /CAFO Dairy		
Company Name:	Falloncrest Farms / John Weststeyn Cattle		
Facility or Site Name:			
Facility/Site Physical Location:	<div style="border: 1px dashed black; padding: 5px; text-align: center;"> Ex. 6 Personal Privacy (PP) </div>		
Geographic Coordinates:			
Mailing address:			
Facility/Site Contact:	Ron Pietersma	Title: Owner/ Operator	
	Phone: Ex. 6 Personal Privacy (PP)	Email:	
	John Weststeyn	Operator	
Facility/Site Identifier:	NPDES CAG018001 / Order R8-2013-0001, General waste discharge requirements for CAFOs (dairies and related facilities)		
NAICS:	112120 Dairy Cattle and Milk Production		
SIC:	0241 Dairy Farms		
Facility/Site Personnel Participating in Inspection:			
Name	Affiliation	Title	Email
John Weststeyn	John Weststeyn Cattle	Operator	
EPA Inspector(s):			
John Tinger	EPA	Engineer	Tinger.John@EPA.gov

The facility has applied for coverage under NPDES CAG018001 / Order R8-2013-0001, General waste discharge requirements for CAFOs (dairies and related facilities) withi

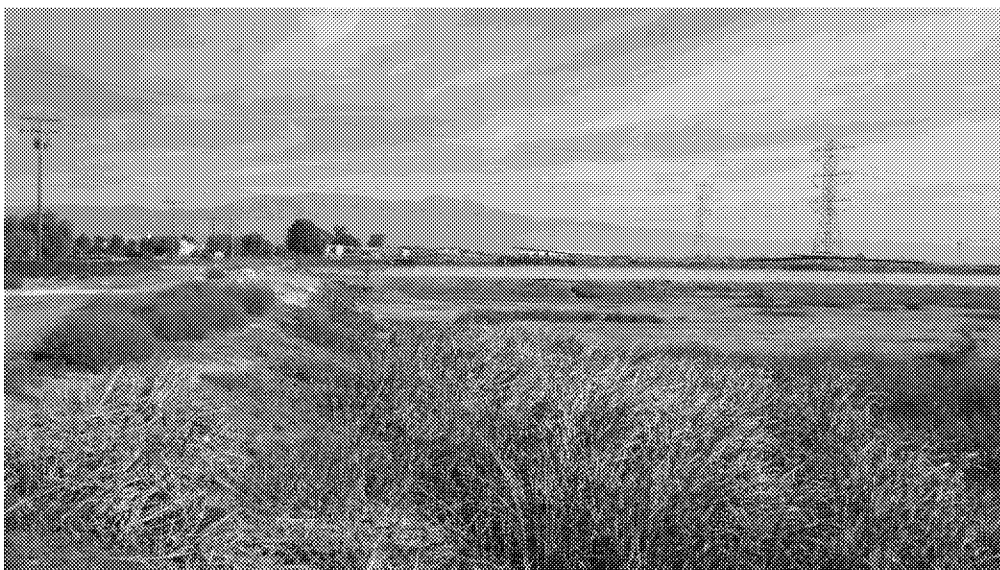
Ponds appeared to contain excess accumulated sediment and excess vegetation (see photos 2, 3, 4). At the time of the inspection, the operator stated the facility began removing solids from the northeastern corner of the north pond about 6 weeks prior to inspection. The area of solids removal was observed in a small portion of the northern pond (see photo 4). The remaining solids in the area appeared to be fairly wet. The operator stated removal of solids was currently suspended due to wet conditions in the basin which prevents a loader from working. The operator stated that they expect to have solids removal completed within about a month, provided the weather remains dry. The solids have been moved to the former calf ranch area to dry before hauling off site.

Photo 2: western edge of Northern Pond: excessive solids and vegetation in pond.

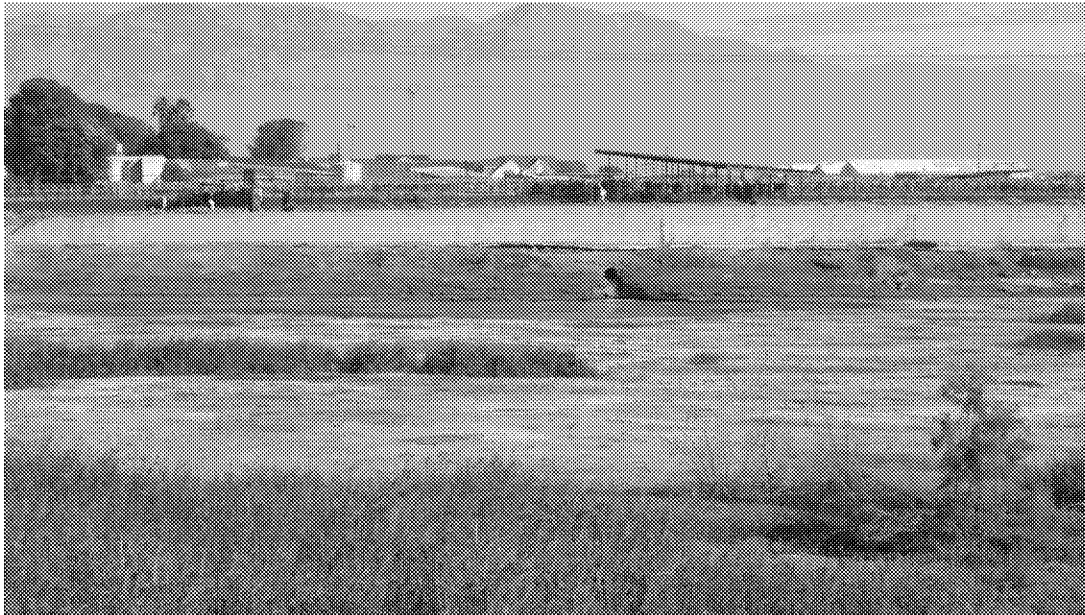
Photo 3: Northern edge of northern pond. Pond actively receiving washwater. View looking north. Excessive solids and vegetation in pond.

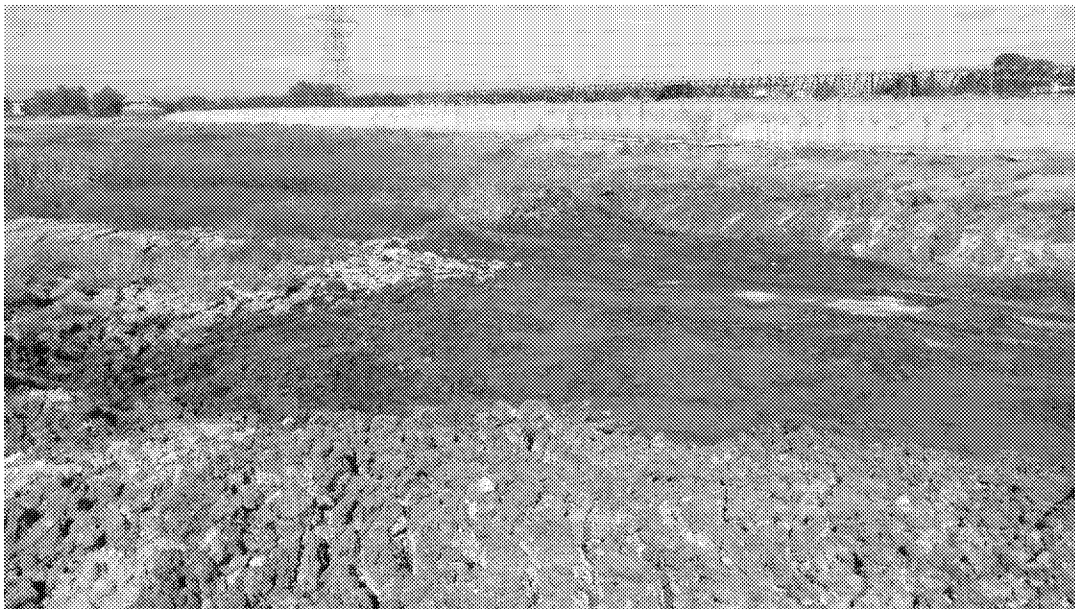
Photo 4: Eastern edge of Northern pond. Solids recently been removed.

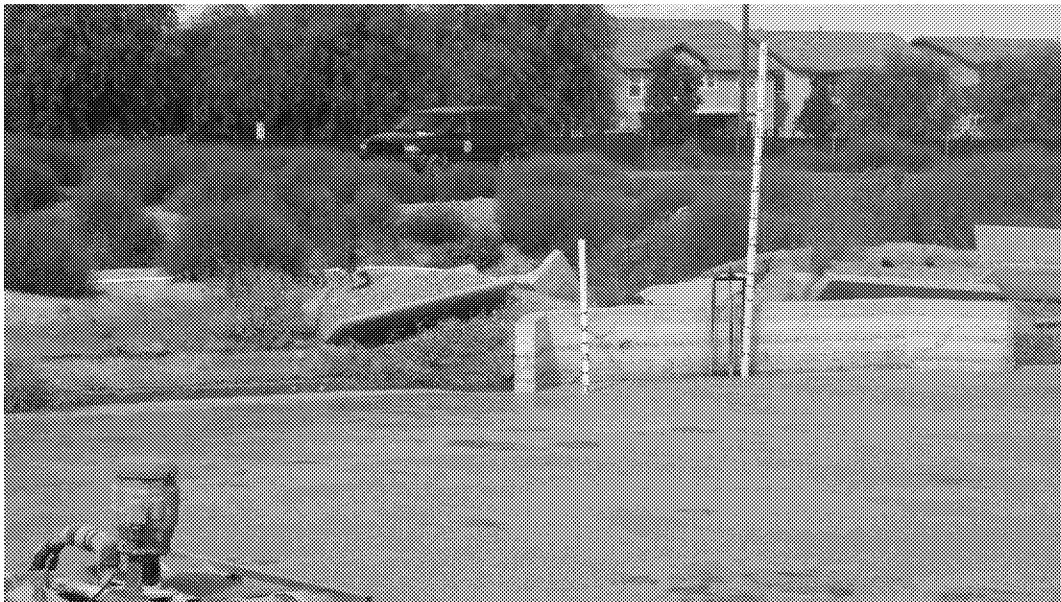
Photo 6: southern pond; depth marker; pump in foreground

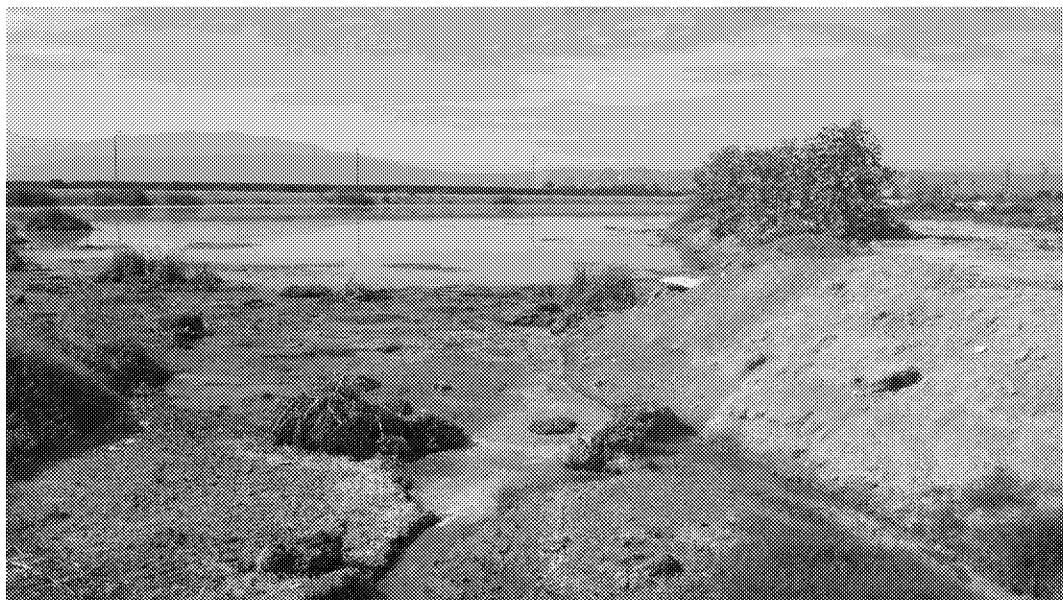
Photo 7: Washwater draining into Southern Pond at eastern boundary. View looking southwest

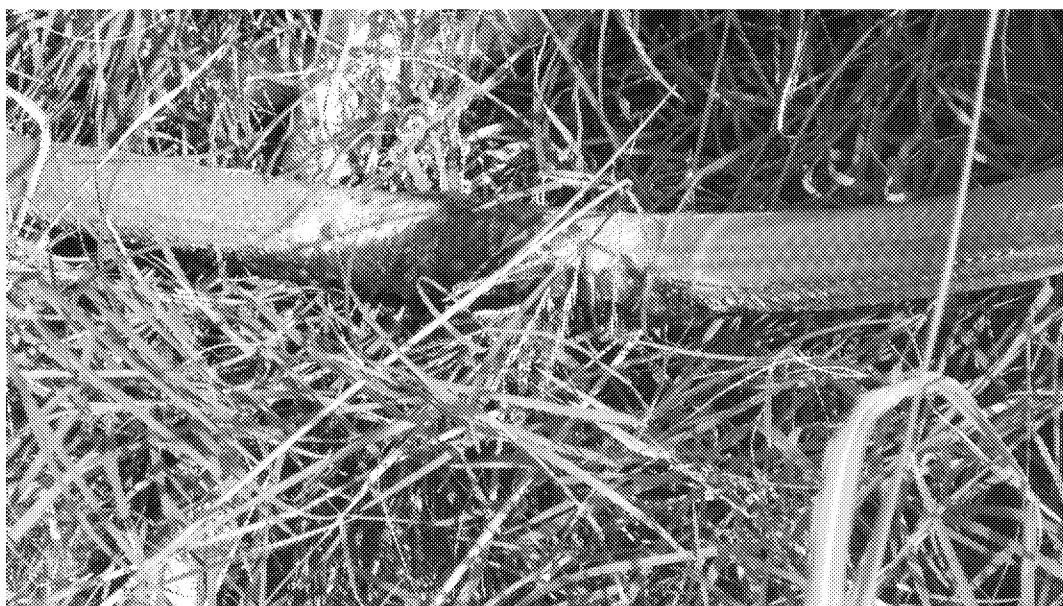
A broken water line was observed draining into the wastewater lagoon (see photos 8-9). Algae growth was observed both on the waterline hose and on the pavement downstream of the leak, indicating the presence of the leak for an extended amount of time.

Photo 8: Broken water hose discharging to southern pond.

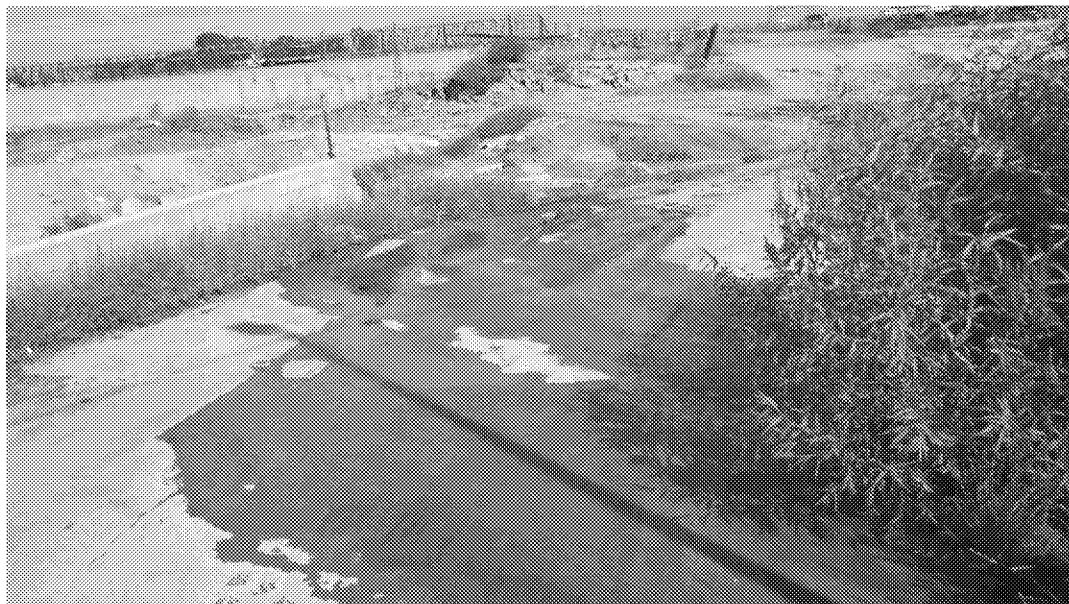
Photo 9: Broken hose discharging to southern pond.

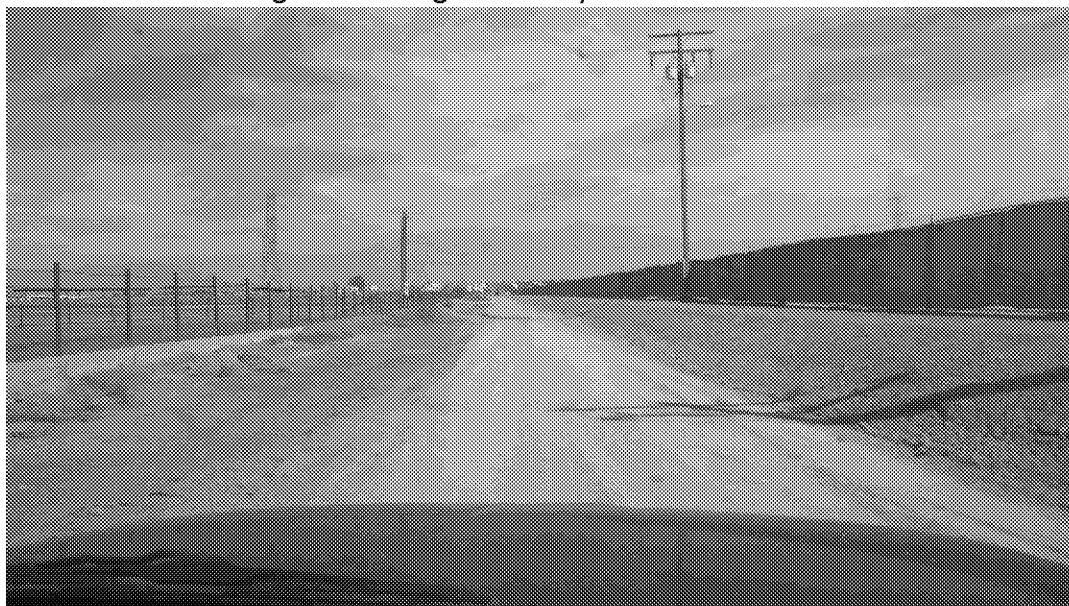
Berms appeared in satisfactory condition.

Photo 10: berm along eastern edge of facility

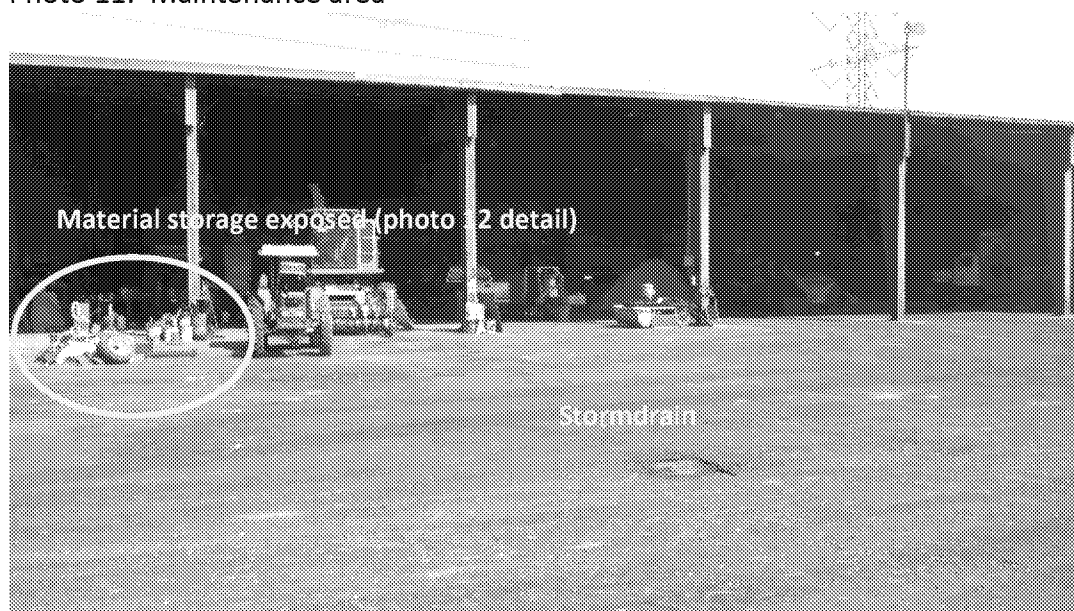
At the maintenance area, numerous issues were observed of improper chemical storage, improper storage of used oil, evidence of oil leaks, improper storage of a battery, and general lack of housekeeping. A stormwater drain was located in front of the maintenance area (see photo 11):

Open containers of used oil were observed at several locations with potential to discharge to the stormdrain (see photos 11, 12, 16, 17, 18). At least one bucket had a label of "hydraulic oil". Evidence of oil stained soil and oil stained pavement was observed at several locations throughout the area (see photos 12, 15, 16).

Photo 11: Maintenance area

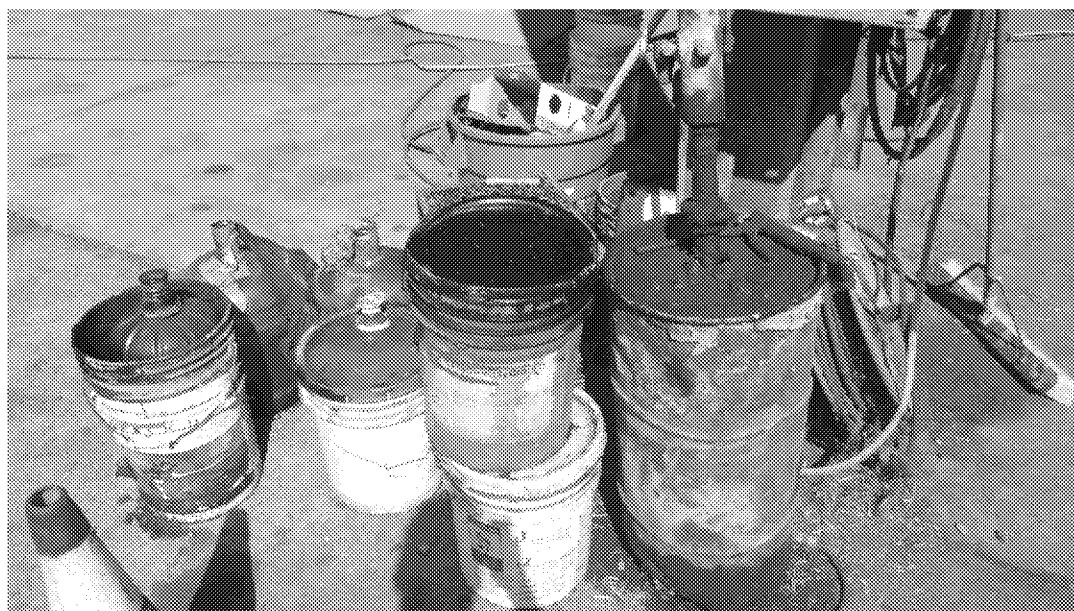
Numerous unidentified containers of liquids were observed stored outside , some leaking, with potential discharge to stormdrain (photo 12, 21).

Photo 12: Maintenance area - detail of Photo 11: improperly stored used oil storage and materials storage.

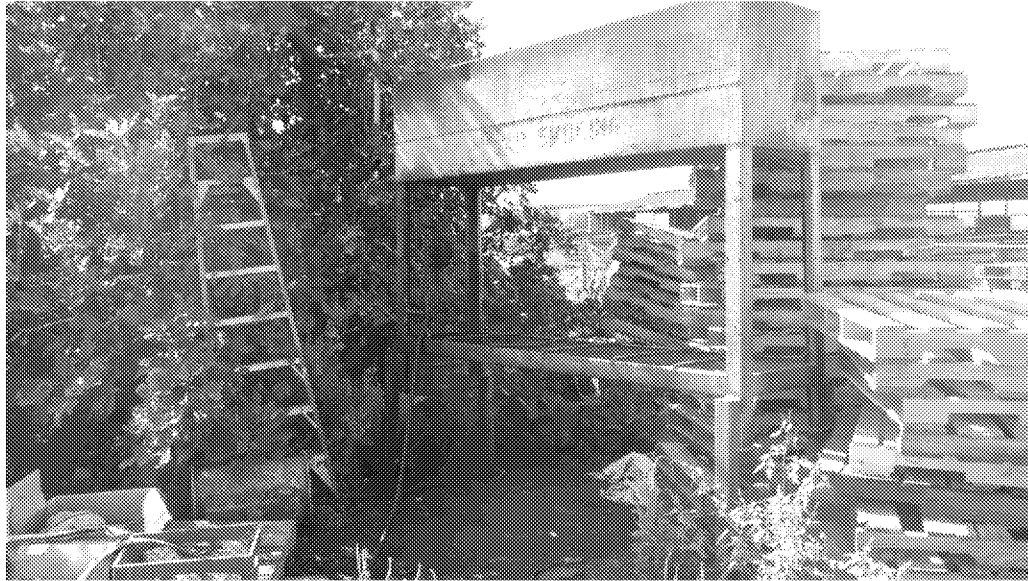
An aboveground rectangular tank was observed with evidence of material leaked onto the ground that appeared to be oil (photo 13, 14, 15). The top of the tank could not be observed and it was unknown if the tank was open-topped or had any liquids stored inside. It was unclear the purpose the tank. "No smoking" was stenciled onto the side of the tank. The valve under the tank appeared to have leaked and the soil beneath the tank was stained.

Photo 13: Maintenance area : tank, leaking valve, spills and staining of soil

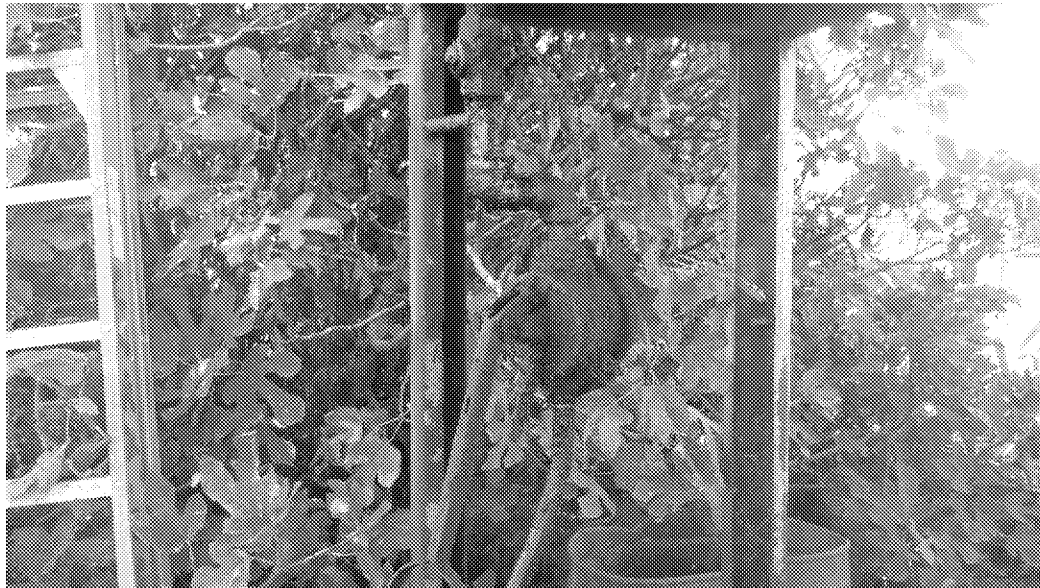
Photo 14: Maintenance area: detail of Photo 13: of leaking valve under tank.

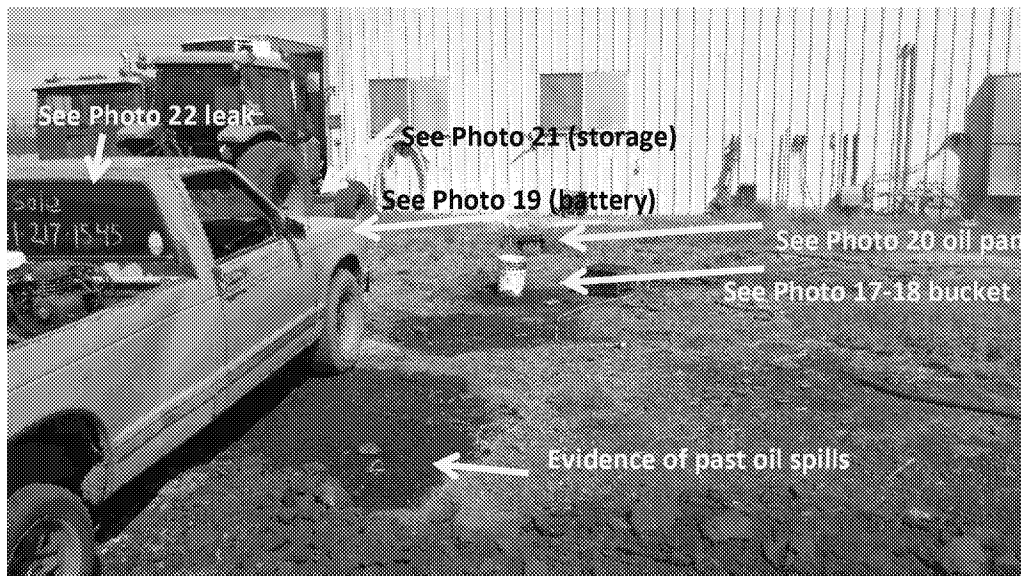
Photo 16: Maintenance area. Southwest corner of maintenance shed. Oil stained soil, improper used oil storage, and improper material storage.

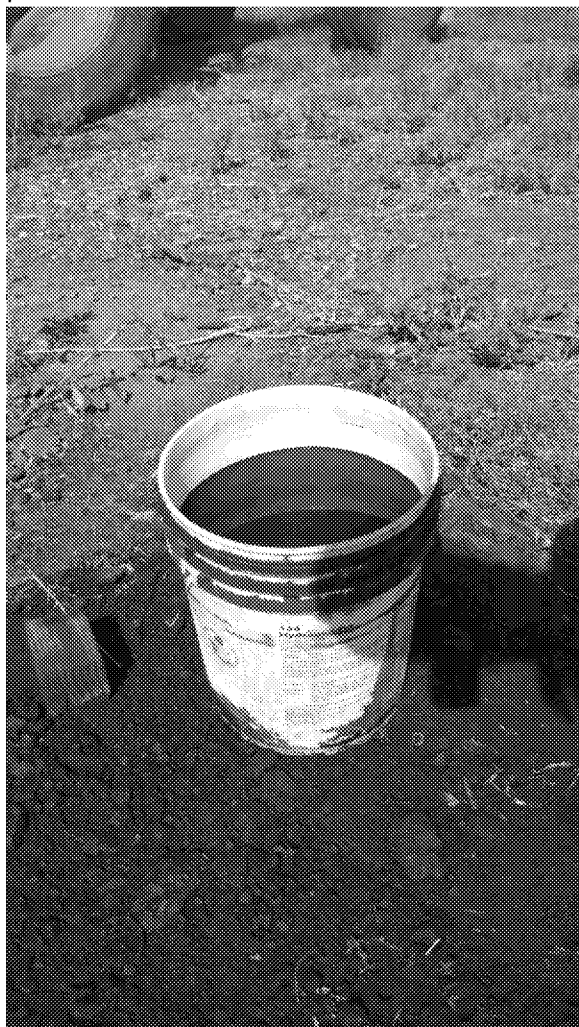
Photo 17 : Maintenance area : detail of
photo 16: Bucket with used oil

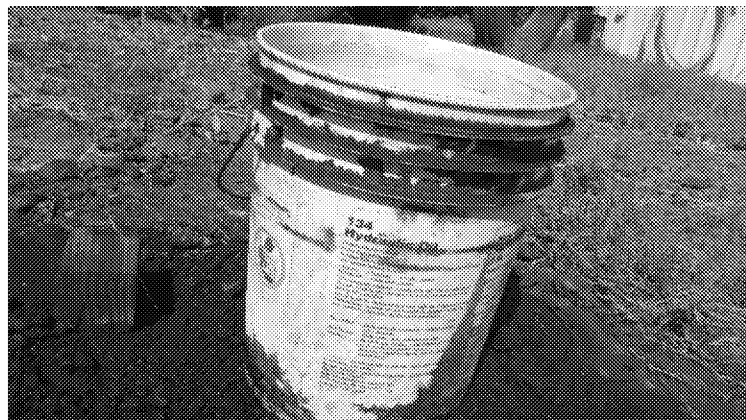
Photo 18: Detail : bucket labeled "Hydraulic oil"

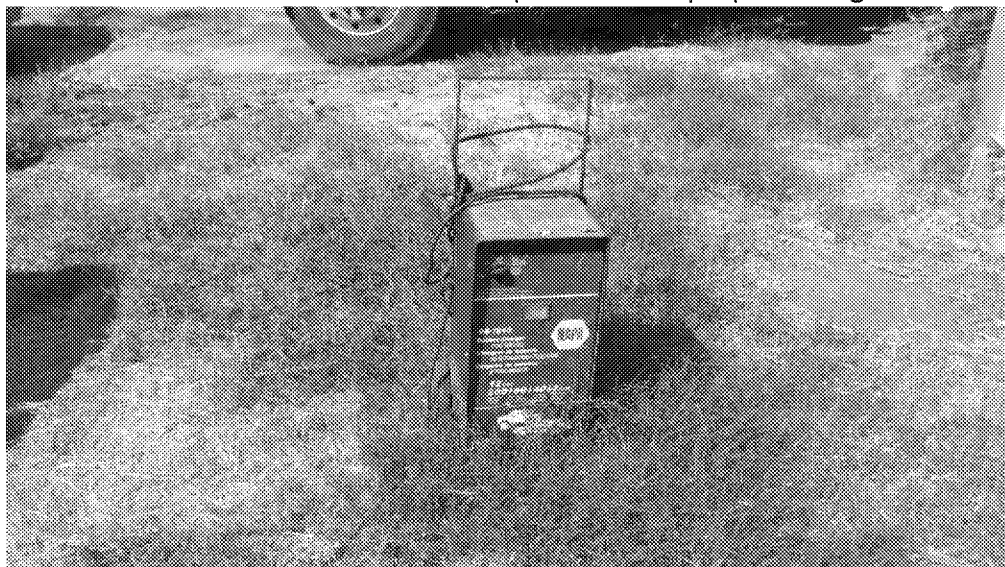
A battery was observed stored outside with potential to leak to stormdrain (photo 19).

Photo 19: Maintenance area detail of photo 16: Improper storage of battery

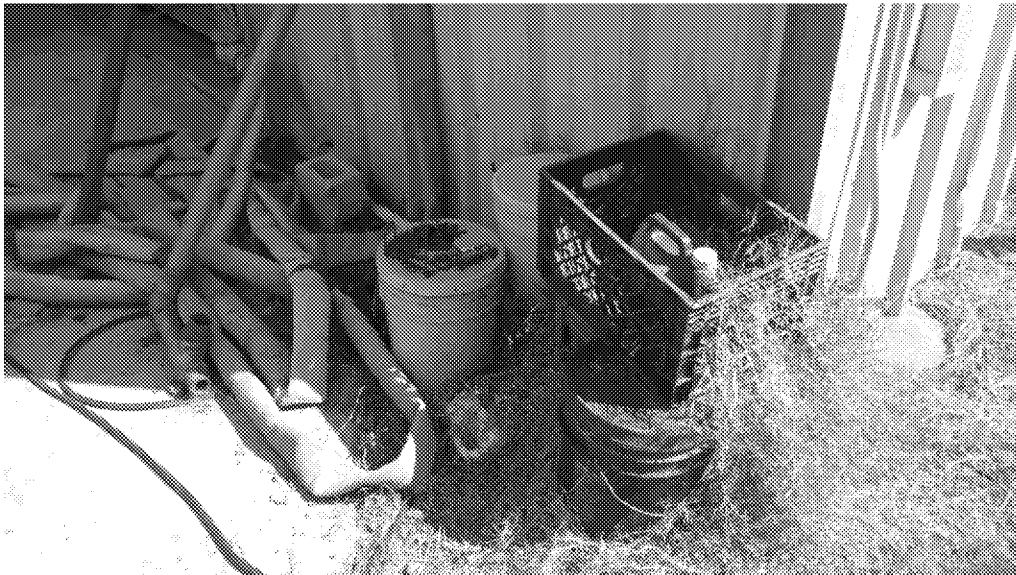
Photo 21: Maintenance area detail of photo 16: Storage of unknown materials at southwest corner of maintenance shed.

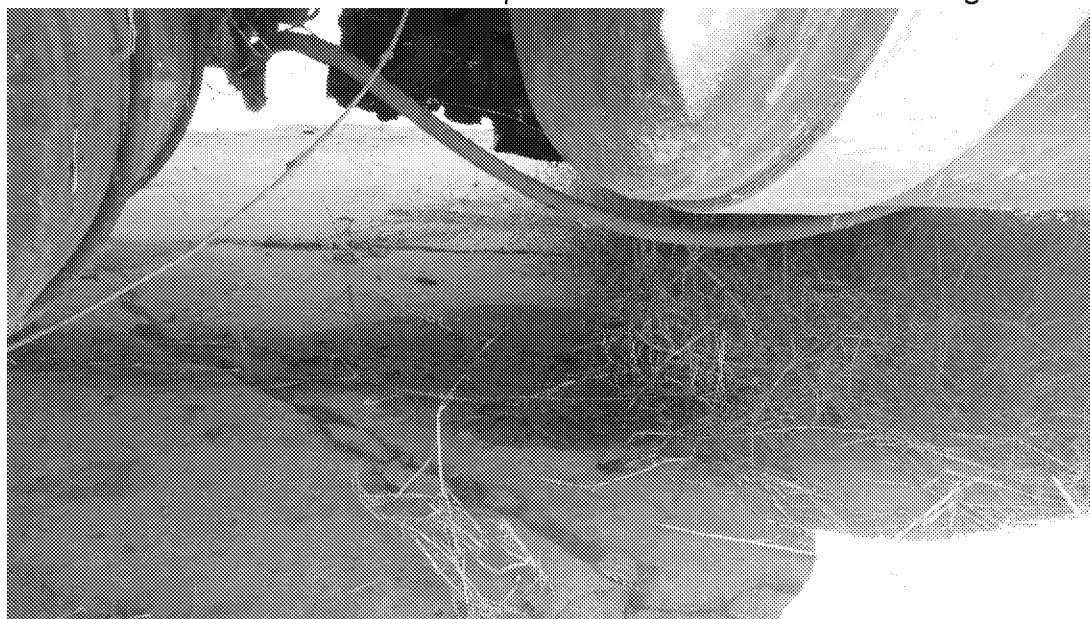
An engine was observed leaking oil onto the pavement with potential to discharge to the stormdrain (photo 22).

Photo 22: Maintenance Area detail of photo 16: active leak from truck engine

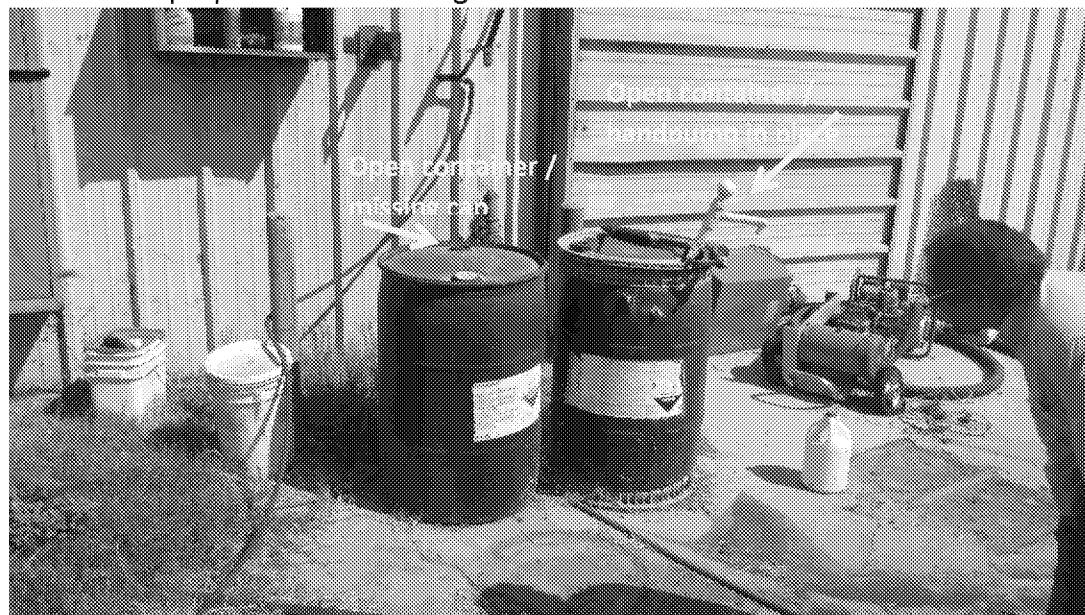
Two 55 gallons barrels were observed without secondary containment with potential to discharge to the stormwater drain. The barrels were both approximately ½ full. One barrel was open due to a missing cap and was labeled "formaldehyde". The second barrel was open due to an installed pump system, and, while the label was partially unreadable, it appeared to be "sodium hypochlorite" brand name "HASACHLOR".

Photo 23: improper chemical storage.

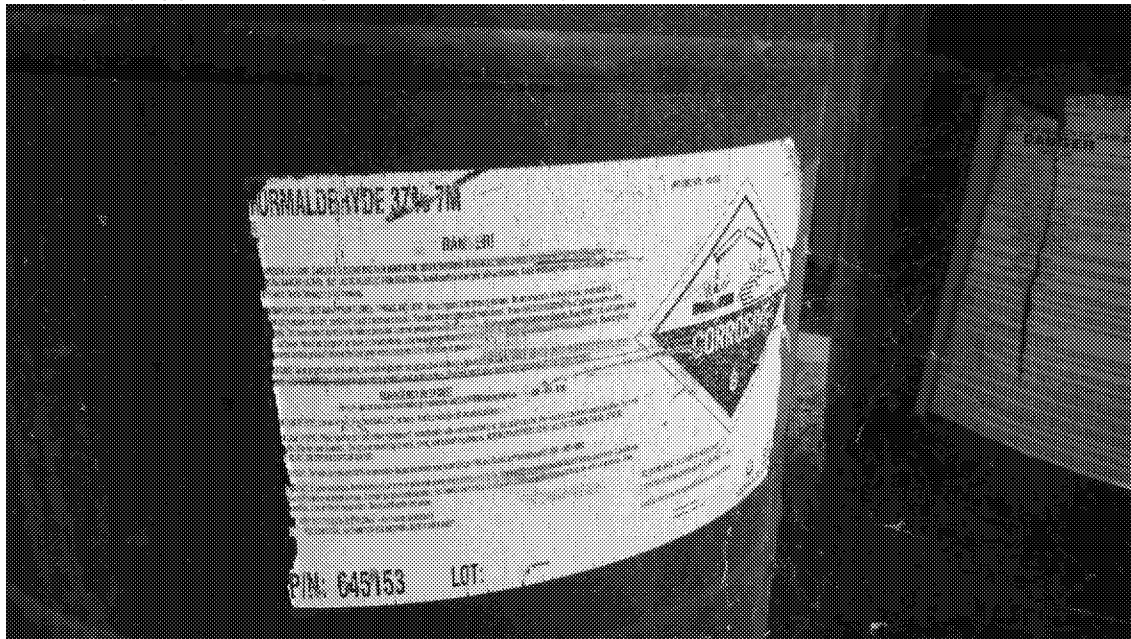
Photo 24: Detail of photo 23: Improper chemical storage, detail label "formaldehyde". Barrel was open, approximately one half full of liquid.

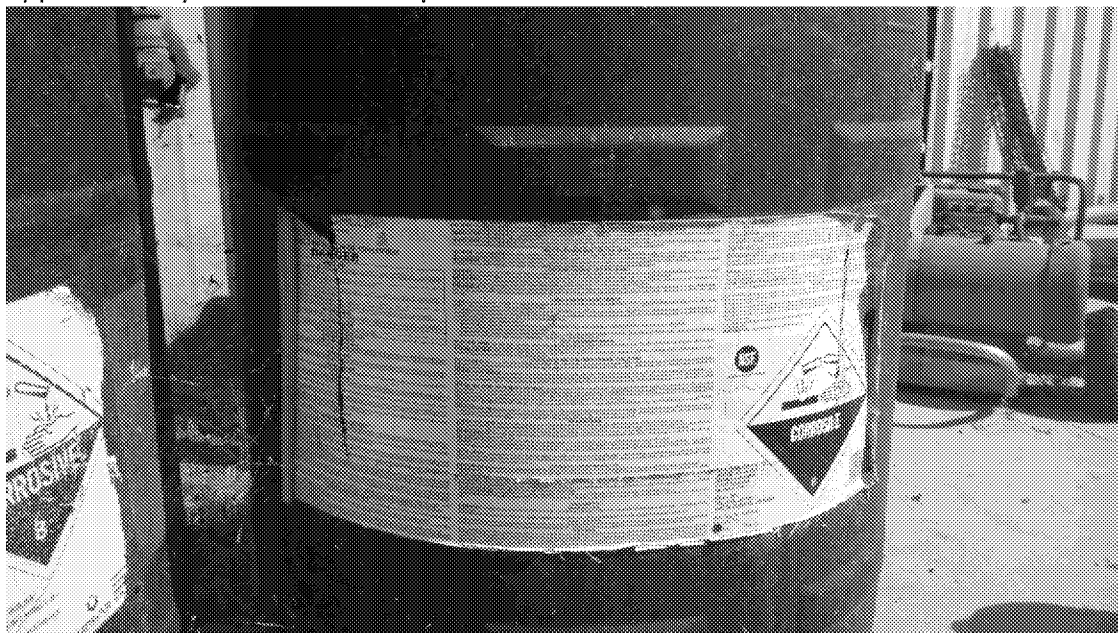
Photo 25: Detail of photo 23: improper chemical storage, detail of label. Label is partially unreadable, but appears to be "sodium hypochlorite" brand name "HASACHLOR". Barrel was approximately one half full of liquid.

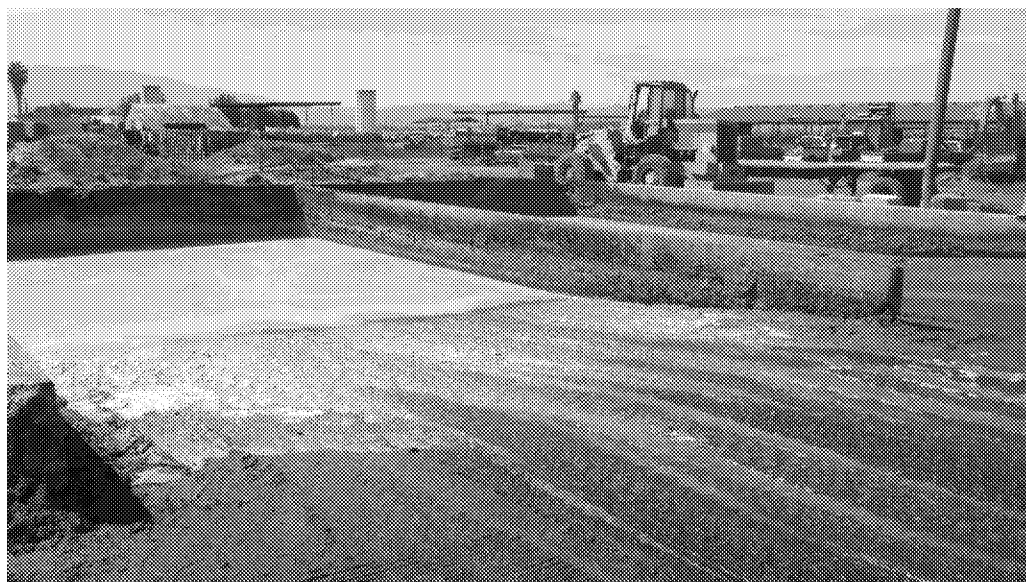
The area at the south end of the maintenance area is used for mixing feed in several concrete basins, including feedstock which may include old ice cream and other milk products (photo 28). The area around the feed area and pavement was stained with material that had the potential to discharge to the stormdrain. (photo 27, 28). The material was dark black but did not have a sheen and was determined to be feed material tracked out from the mixing tanks and was not oil. At the closeout meeting, the operator noted that curdled milk product can have the black appearance of oil.

Photo 28: area of mixing feed.
